Maryland Historical Trust State Historic Sites Inventory Form

Survey No. T-862

and/or common Tilghman Pool Hall

T-862
Tilghman Pool Hall
Tilghman Island Quadrangle

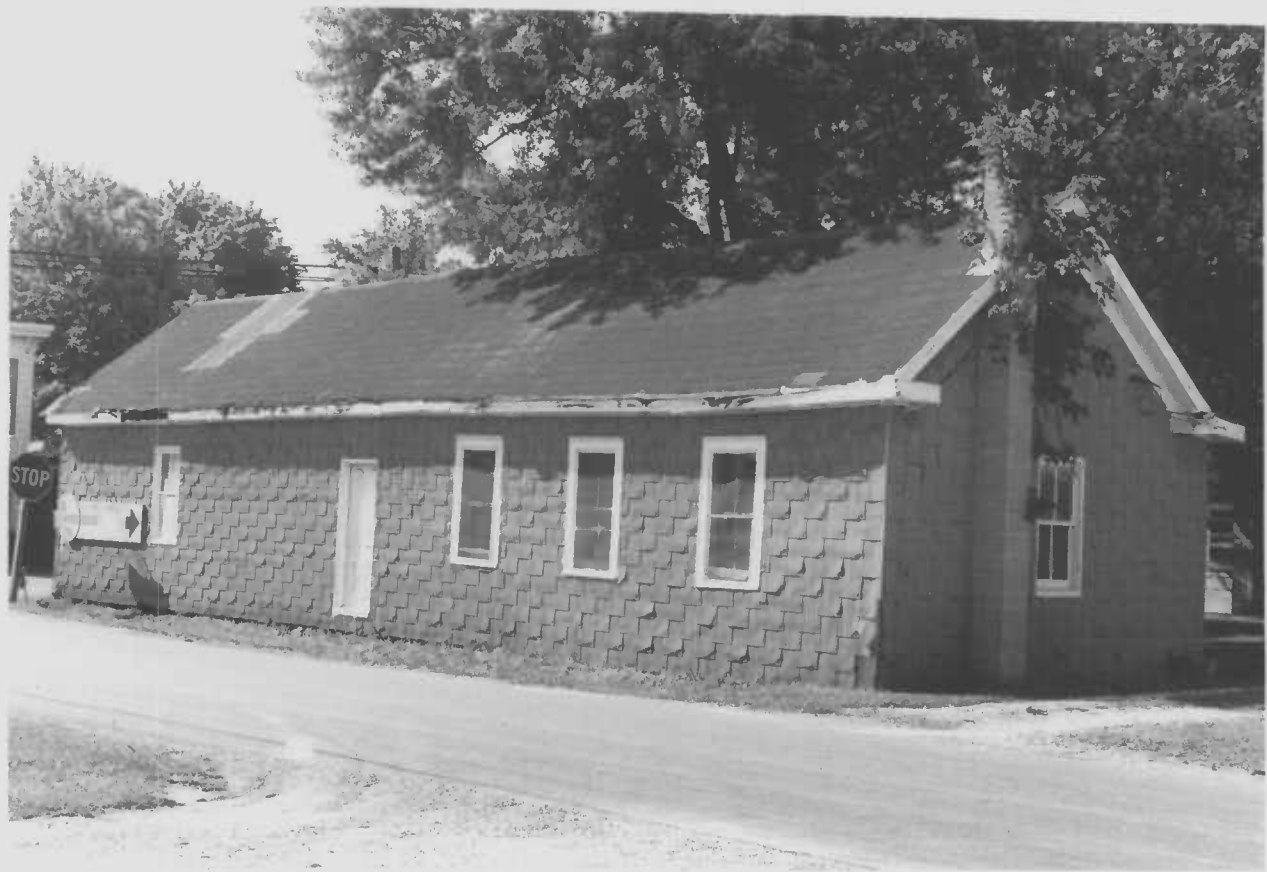
NW ELEVATION.

The northern elevation has three western bays of two-over-two sash windows. A four panel door separates these three bays from one two-over-two sash window at the eastern end of the building.

The west (rear) elevation has a central exterior cinderblock stove stack flanked on the south by one two-over-two sash window. This gable end has shallow cornice returns.
